ON-SITE AIR BAG INVESTIGATION

CASE NO. - 96-20
FLEET - PRIVATE VEHICLE
LOCATION -
ACCIDENT DATE - 1996

1996 Chevrolet Cavalier

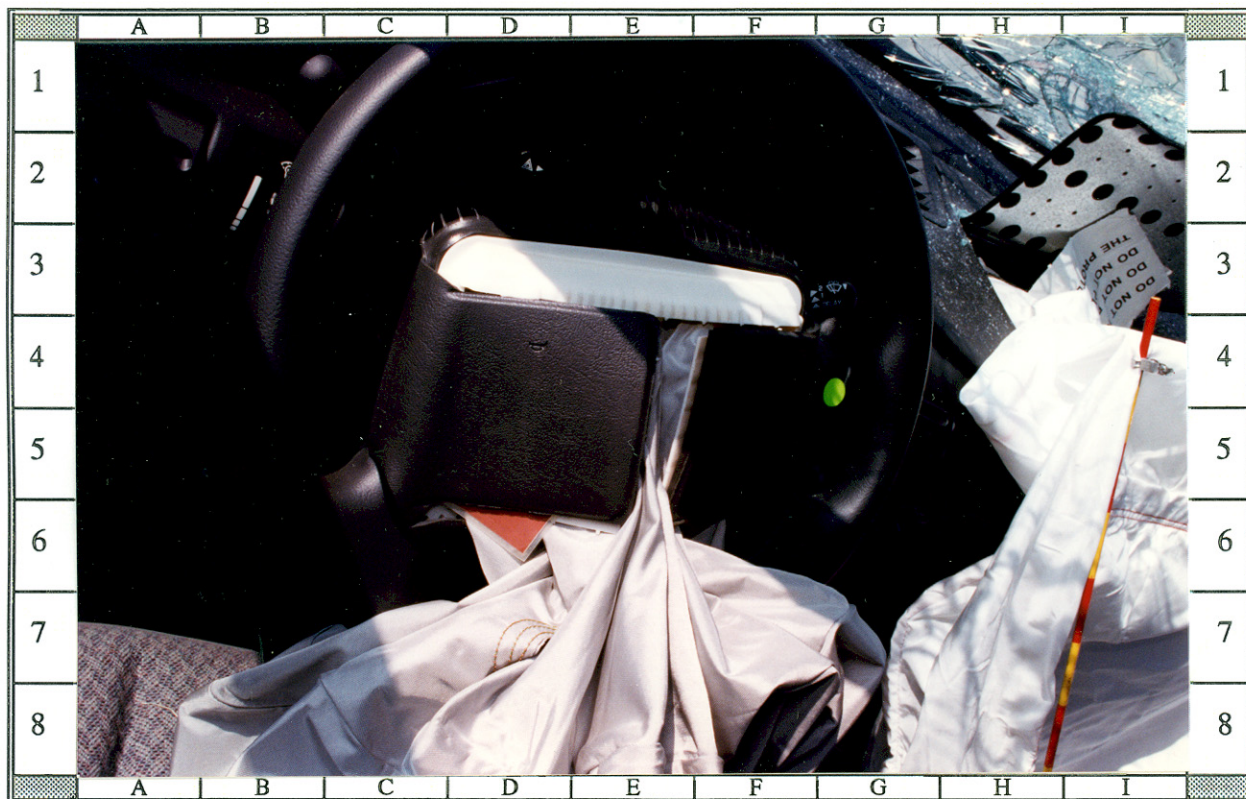
33: Case Vehicle's noncontacted driver side air bag module's cover flaps; **NOTE:** black vertical transfer marks on air bag near top portion of cover flaps

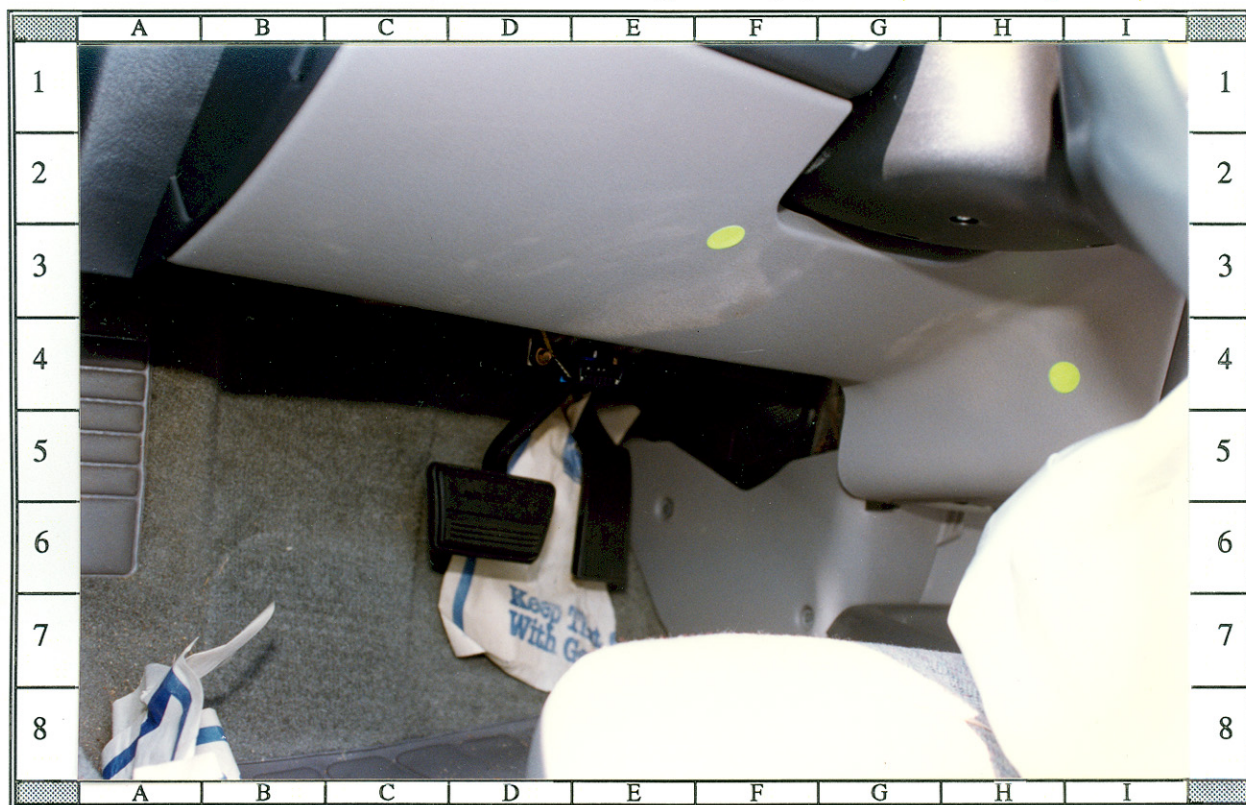
34: Close-up of Case Vehicle's contacted knee bolster on both sides of steering column

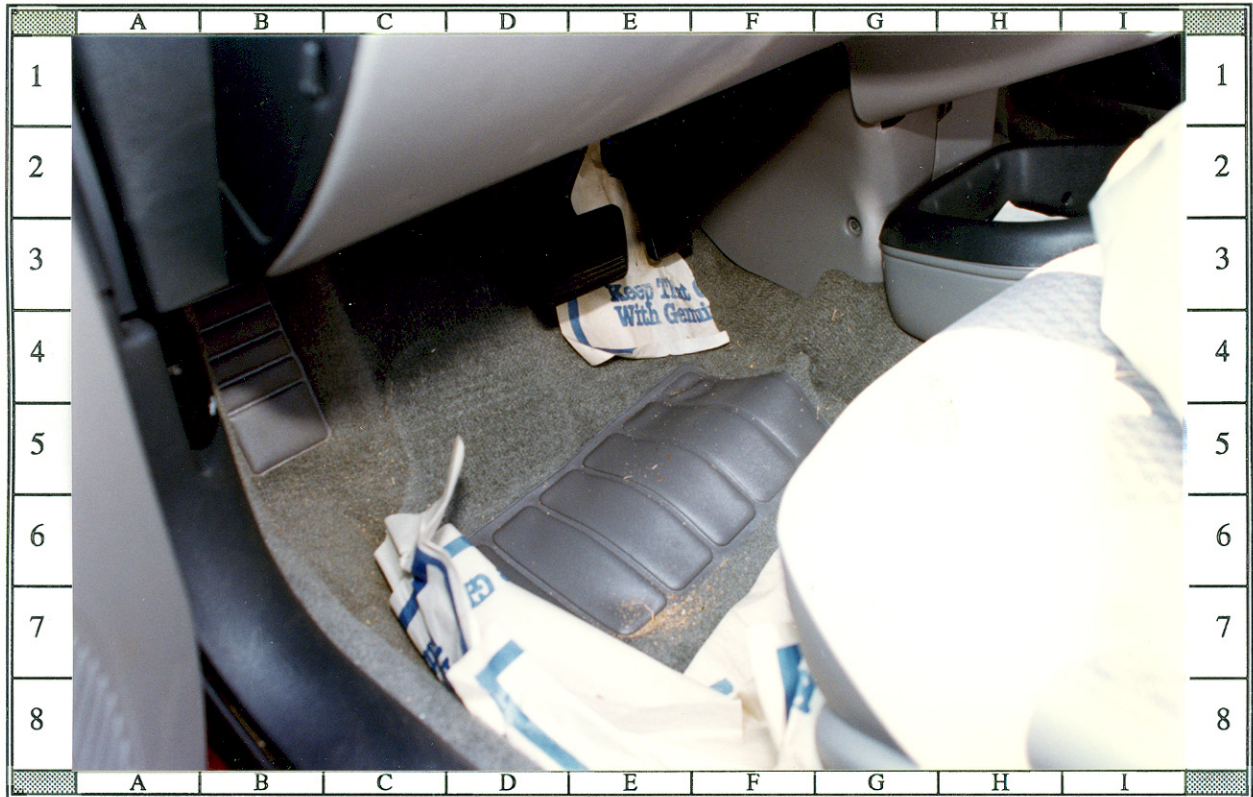
35: Close-up of buckling to Case Vehicle's driver side floor pan

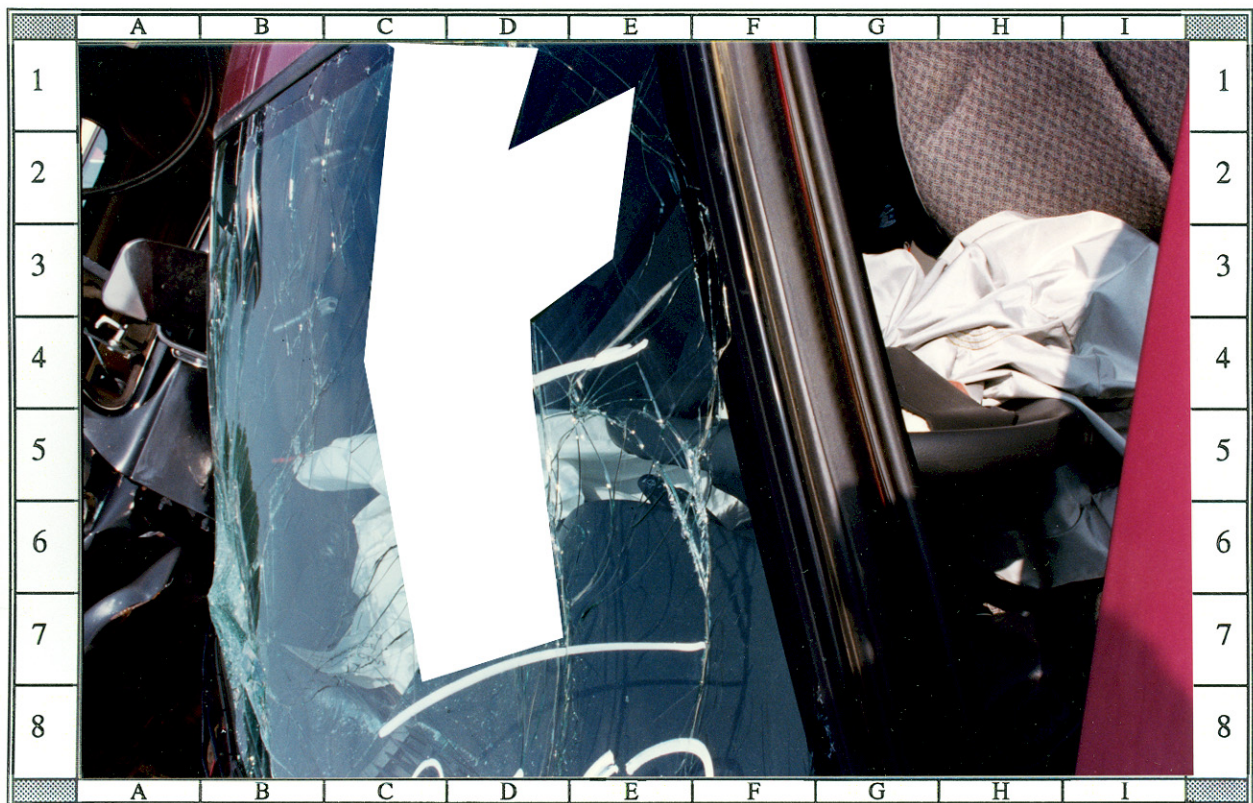
36: Angled close-up through Case Vehicle's damaged windshield showing steering wheel pushed inward toward dash approximately 5 centimeters (2 inches)

According to the vehicle inspection, the steering column was collapsed (i.e., stroked) approximately 5 centimeters (2 inches), indicating that the driver significantly loaded her air bag as she was thrown forward at impact. An inspection of the case vehicle's driver side air bag revealed what appeared to be oil and skin transfers to the right side of the air bag indicating contact by the case vehicle's driver. Based on the lack of driver reported seatbelt pattern bruising and the lack of loading evidence (moderate speed crash) found on the driver's belt system, this contractor believes that no safety belts were used. It should be noted that the case vehicle was not equipped with a shoulder belt adjustor. According to the case vehicle's driver, she sustained a bruise to her right forearm from the air bag and bilateral knee contusions from the driver side

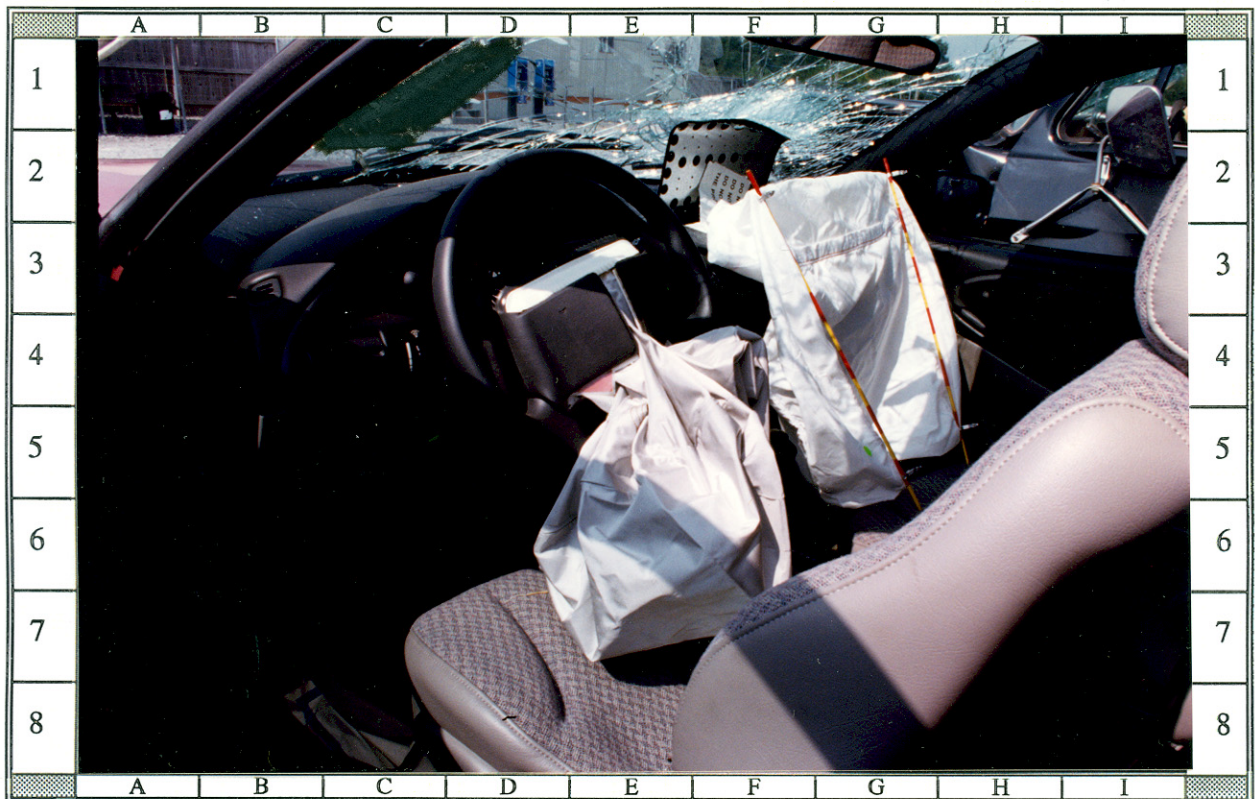
37: Panoramic view of Case Vehicle's front seating area showing deployed air bags and damaged glazing

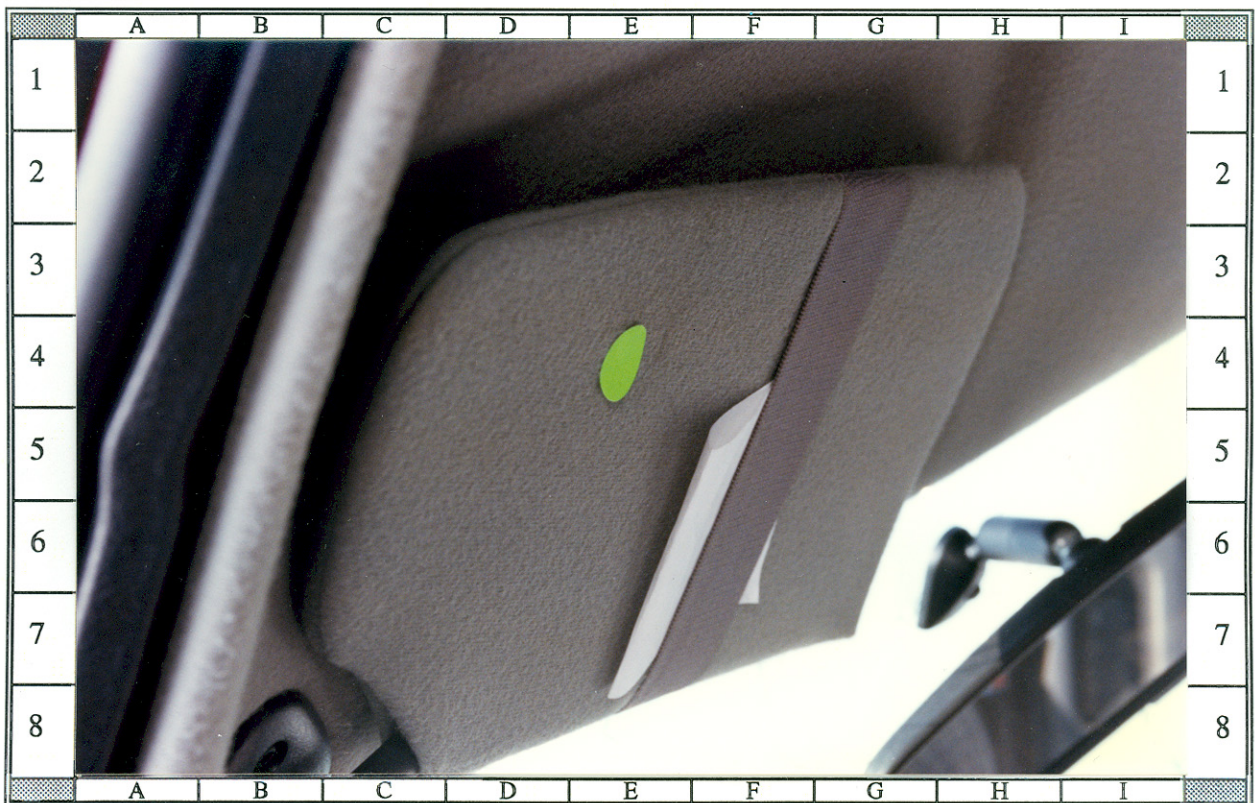
38: Case Vehicle's driver side sunvisor showing contact from driver's head

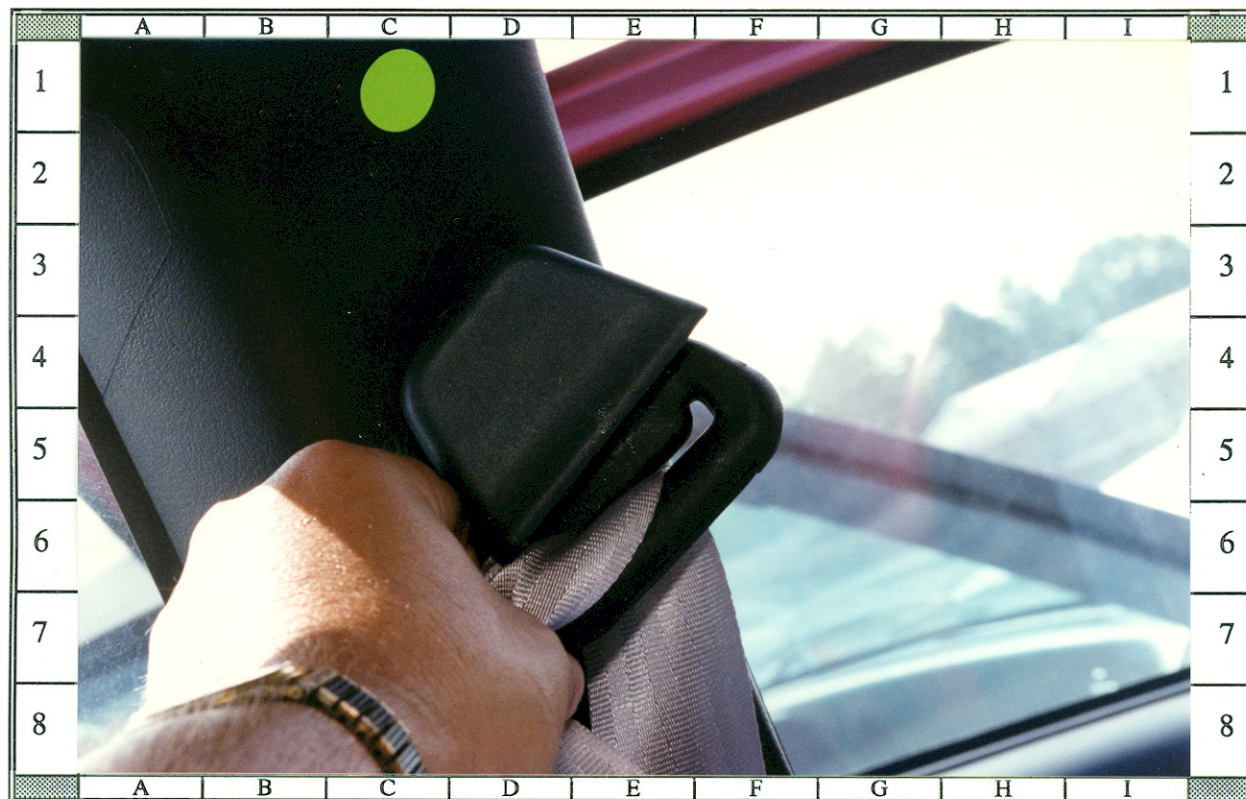
39: Case Vehicle's driver side seatbelt's "D"-ring showing no evidence of loading or usage during crash

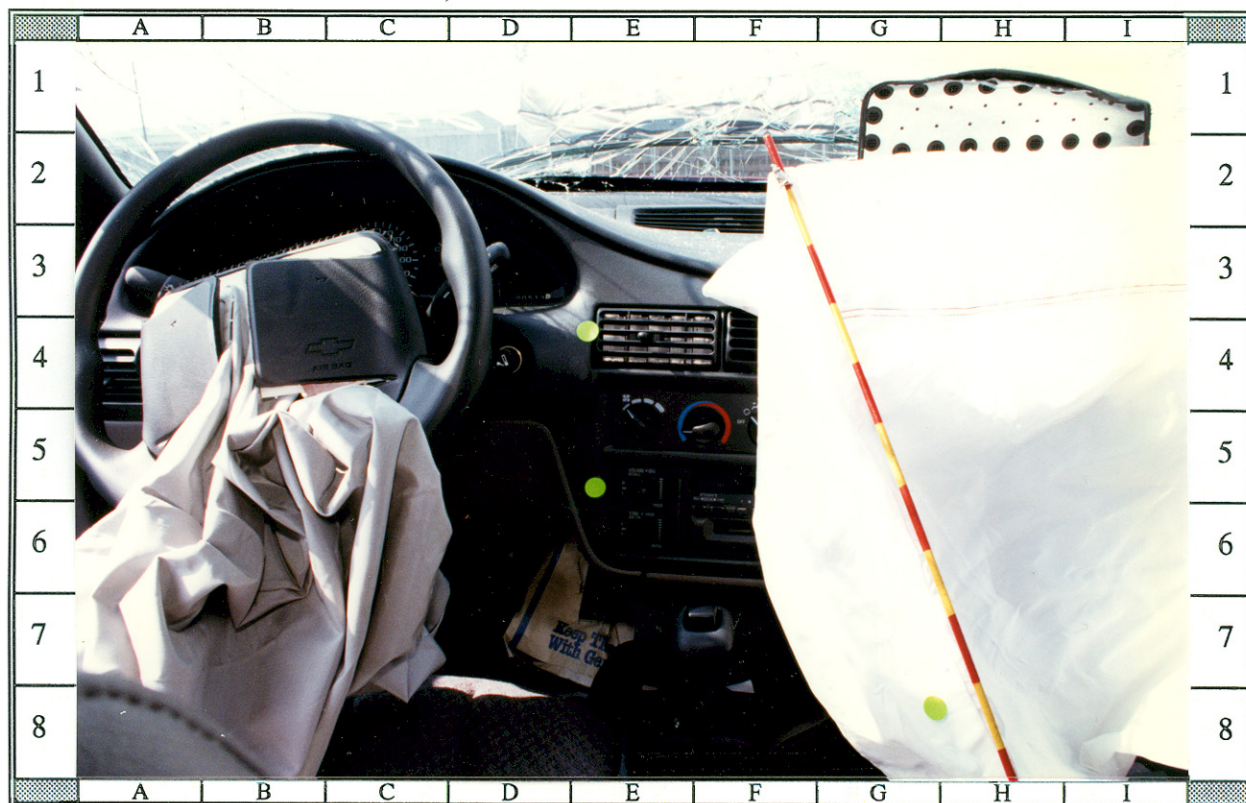
40: Case Vehicle's contacted center console and left edge of right front passenger air bag

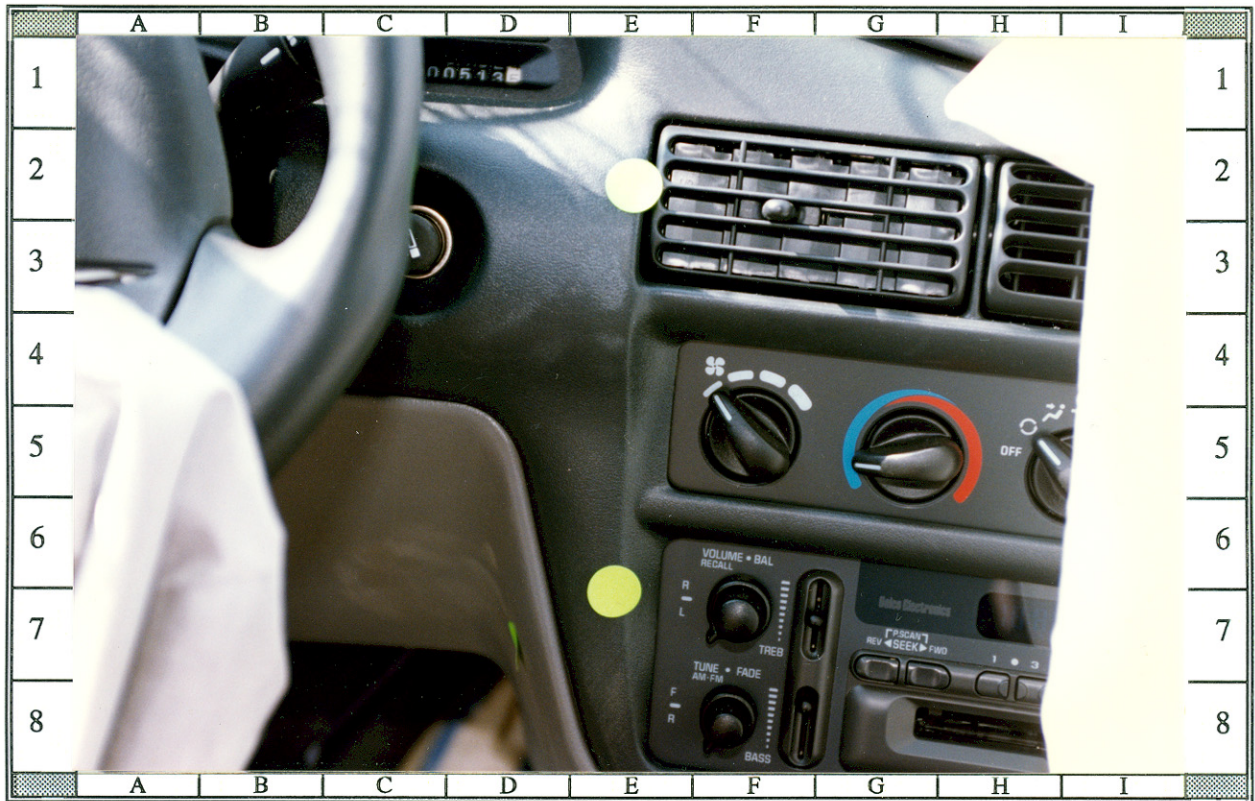
41: Close-up of Case Vehicle's contacted center console (i.e., between dots); NOTE: skin transfer (cell E3) is from right front passenger's head

It is not known exactly what caused the trauma to the child's head. After carefully inspecting the interior of the vehicle thoroughly, we decided that the only object in the interior that could have caused the injury was the console. It is slightly rounded and padded. This would account for there being no contusion around the head wound. We believe that if the child was beginning to sit up at the time of impact, then when the bag deployed, the force of the bag drove her down hard onto the console cover.

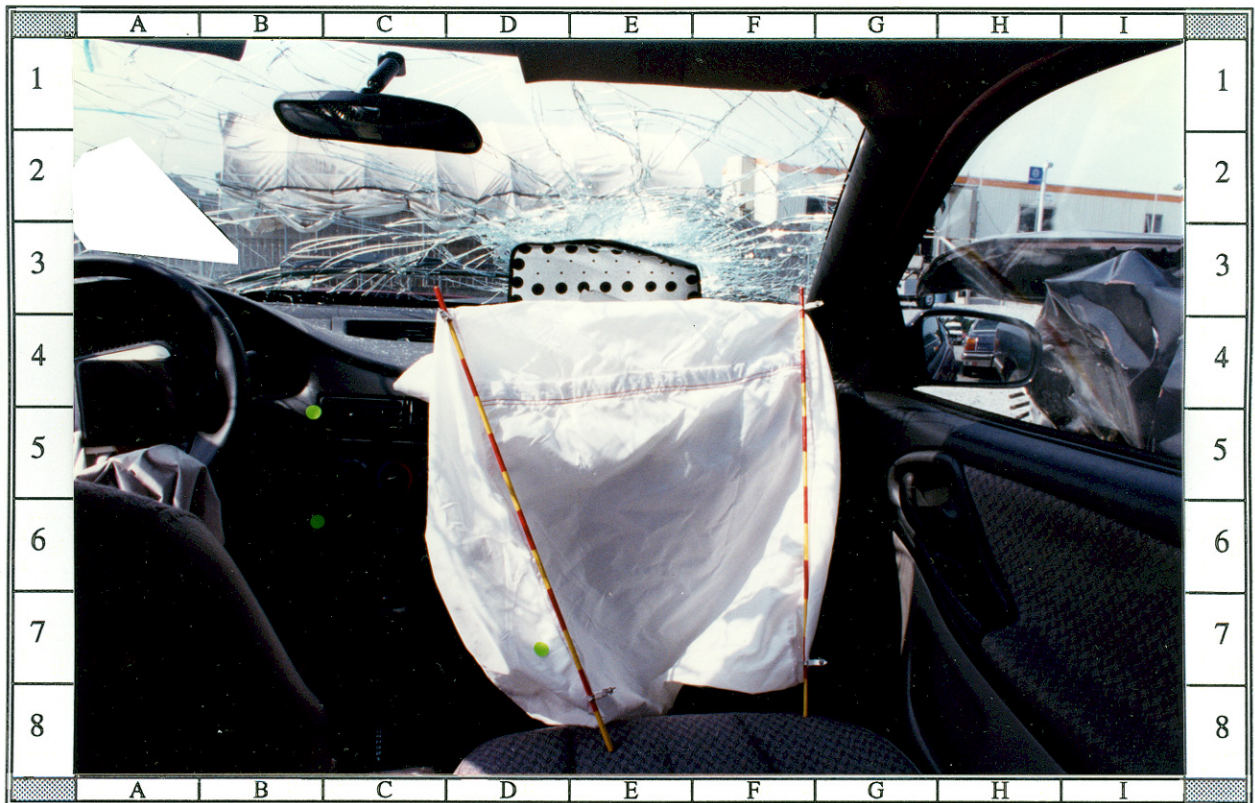
42: Case Vehicle's contacted center console and deployed right front passenger air bag; NOTE: rearview mirror contacted by air bag

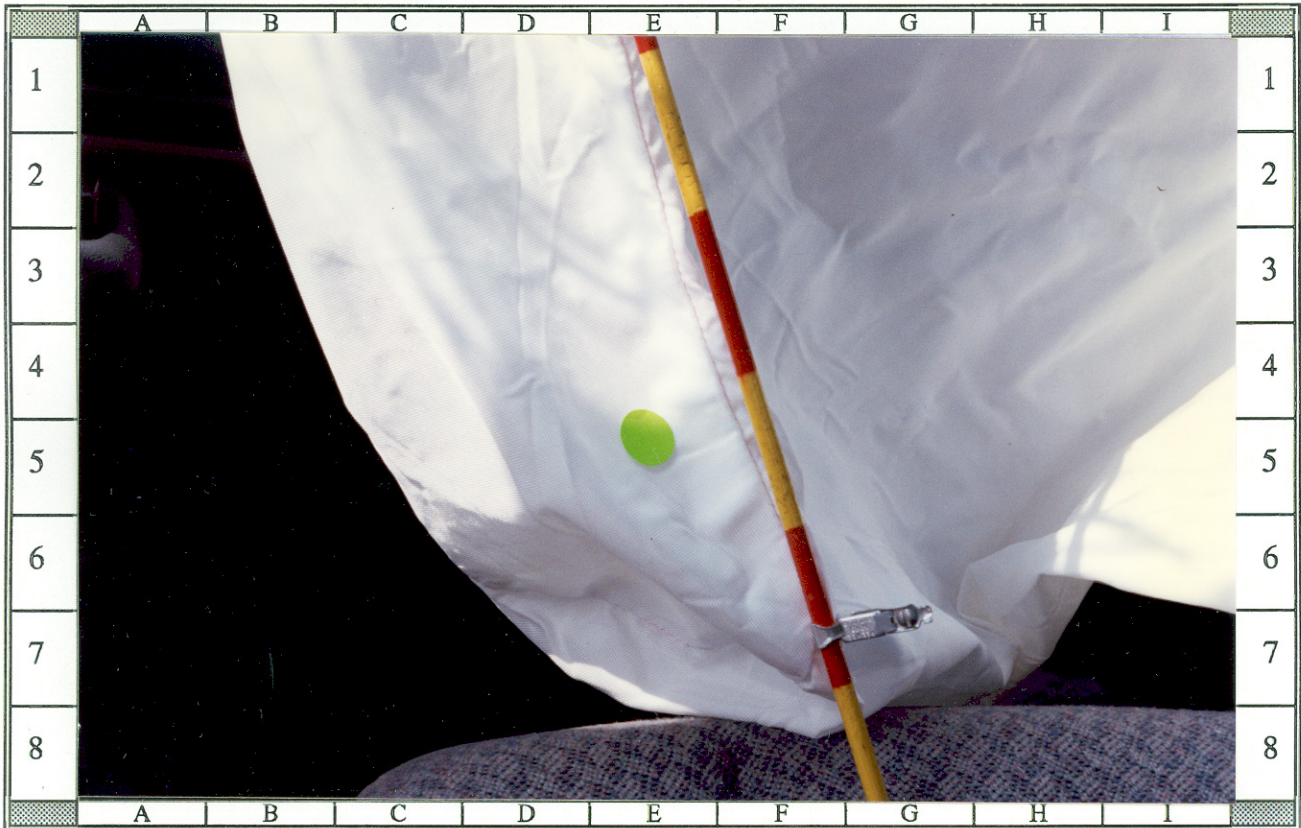
43: Close-up of observed contact area to left lower edge of Case Vehicle's right front passenger air bag

Based on the Police Accident Report, the vehicle and scene inspections, and occupant kinematic principles, the case vehicle's impact with the culvert not only deployed the right front air bag, but thrust the right front passenger forward and slight upward where she contacted the center instrument panel, floor mounted transmission selector lever, and deploying right front air bag. Based on this occupant's pre-crash posture, the case vehicle's impact with the culvert would have thrown this occupant's head forward where the vehicle inspection found a contact to the corner of the padded center dash (see **SELECTED PHOTOGRAPHS #40 and #41**). In addition, the inspection of the right front air bag revealed what appeared to be oil and skin transfers to the left edge of the air bag indicating possible contact with this occupant's legs.

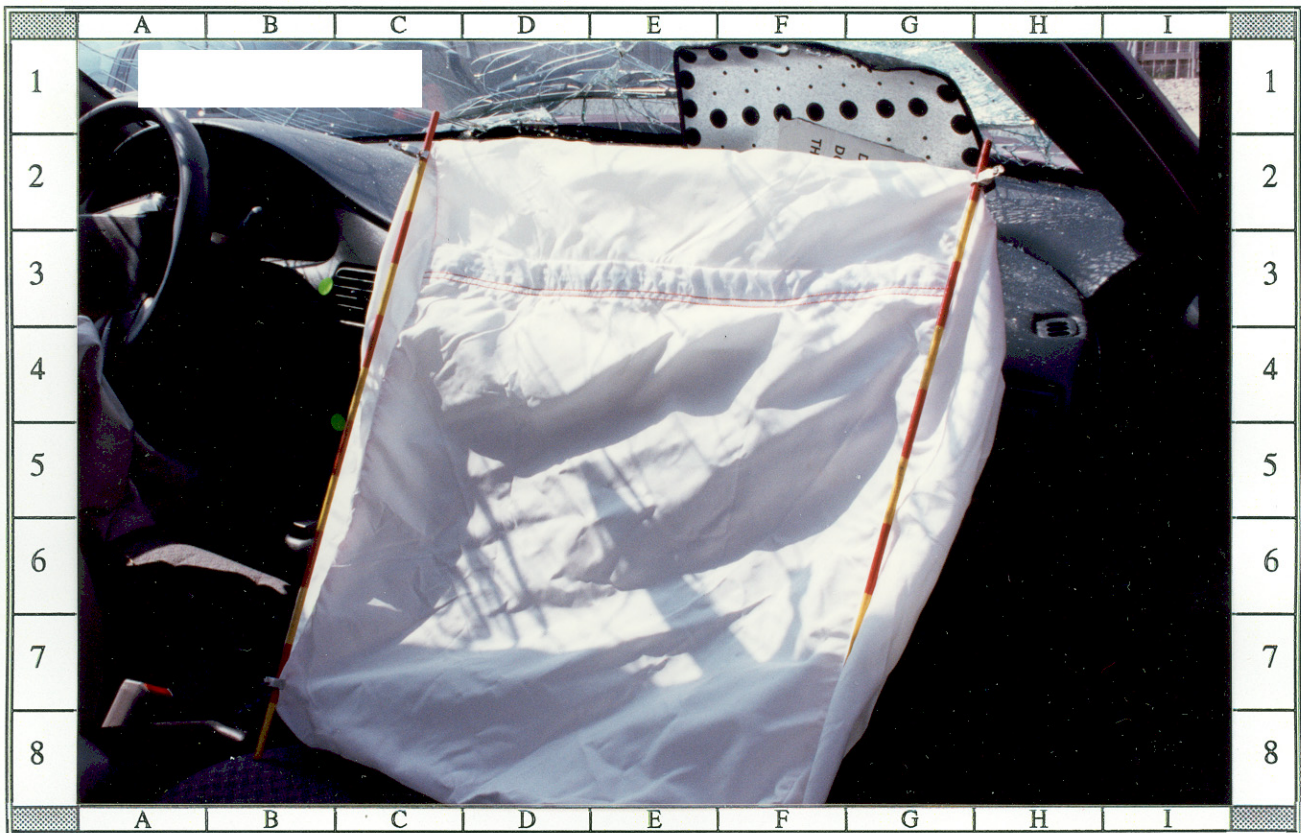
44: Case Vehicle's deployed right front passenger air bag; NOTE: no obvious contact evidence found to front of air bag

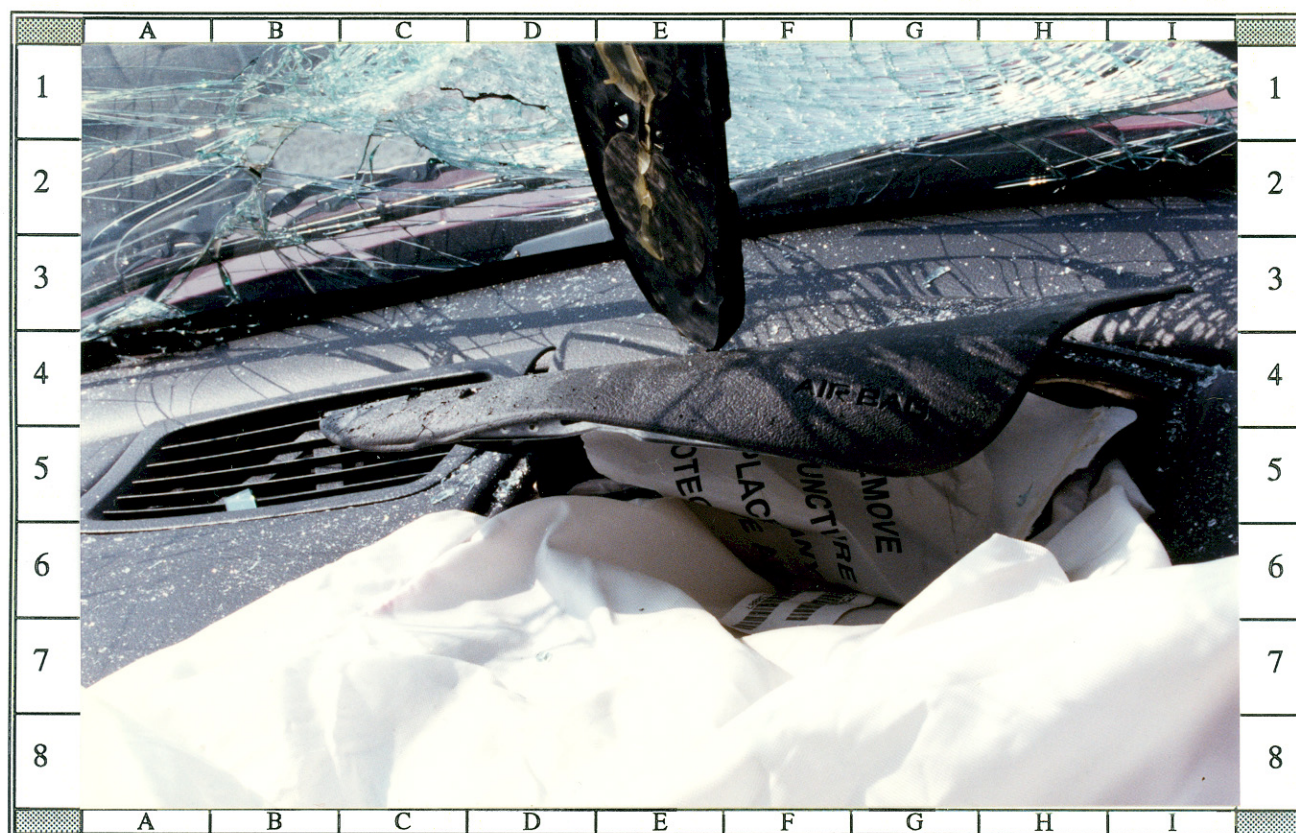
45: Case Vehicle's noncontacted but damaged (i.e., from striking windshield) right front air bag module's cover flap; NOTE: plastic piece holds up windshield

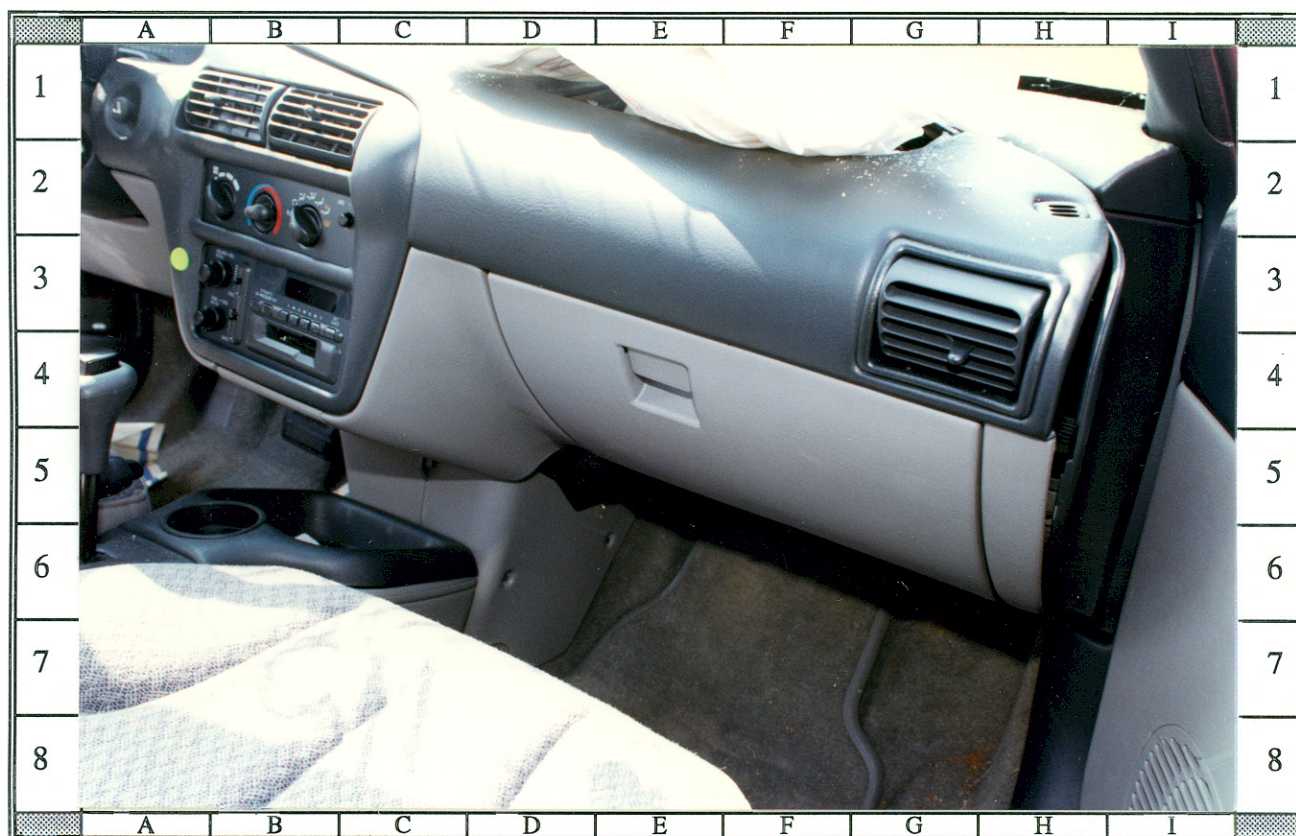
46: Case Vehicle's right front glovebox and knee bolster; NOTE: no evidence found of occupant contact

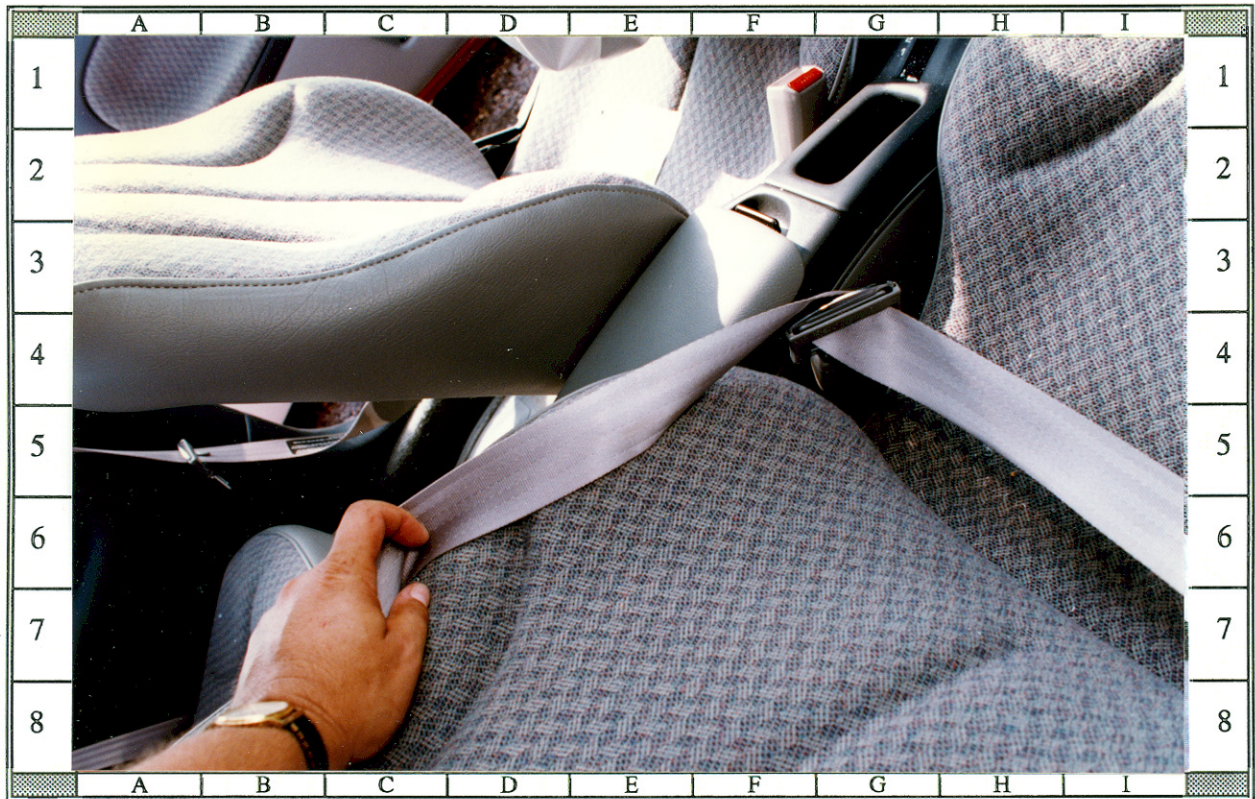
47: Case Vehicle's right front passenger seatbelt showing no visible evidence to outside of webbing (e.g., blood)

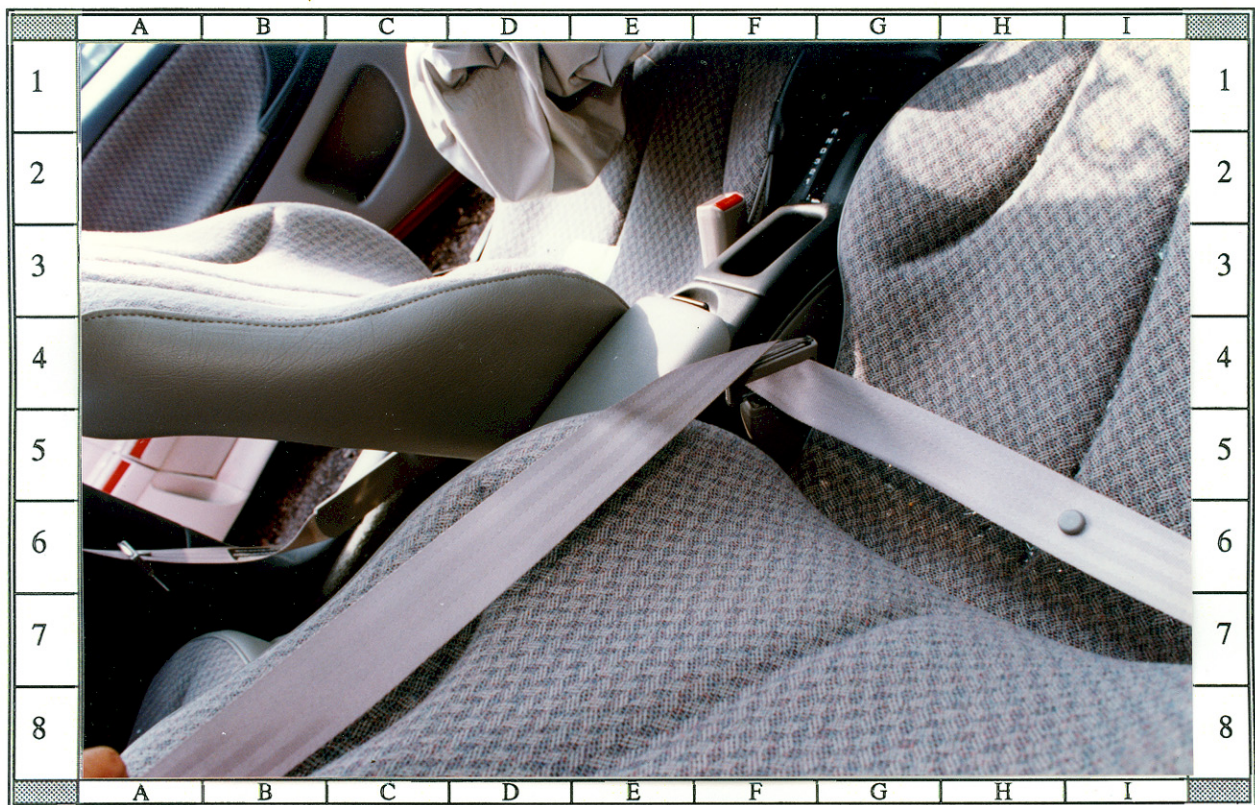
48: Case Vehicle's right front passenger seatbelt showing no visible evidence to inside of webbing (e.g., blood)

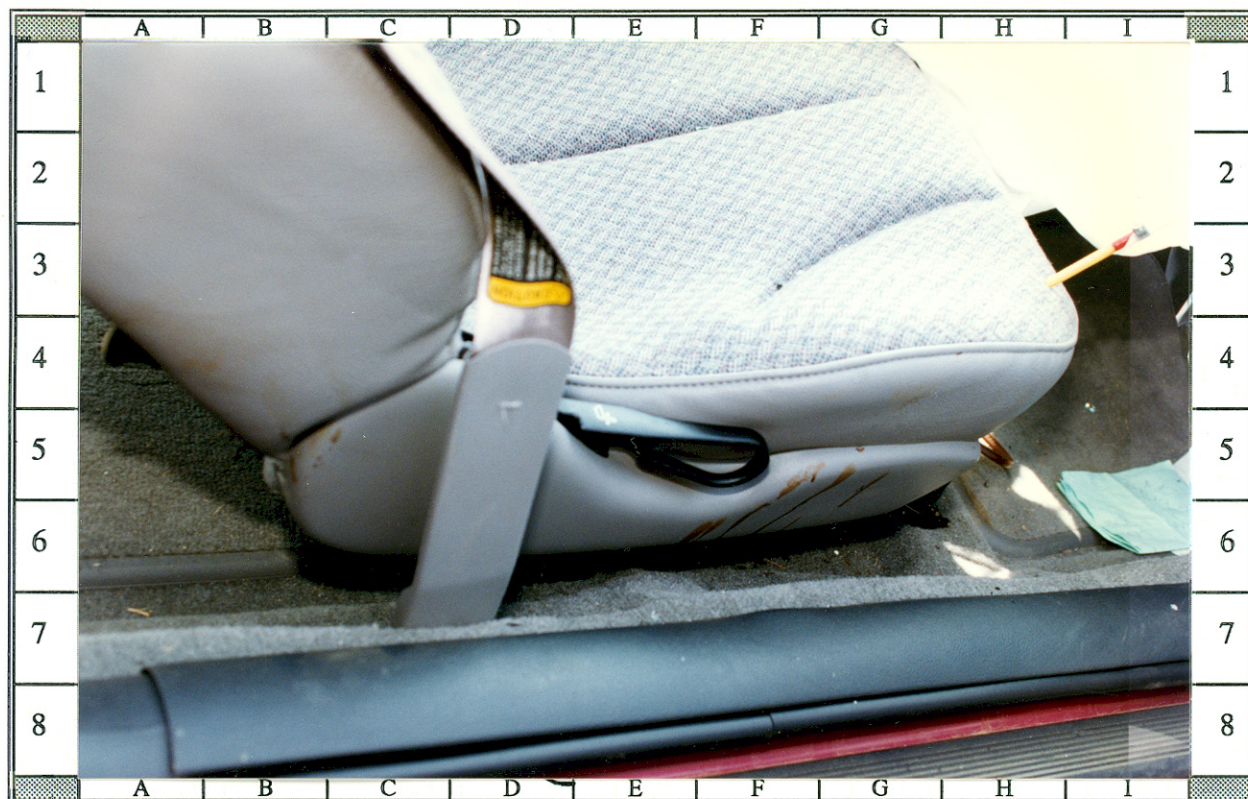
49: Case Vehicle's right front passenger seat showing dried blood drainage to outward base of cushion

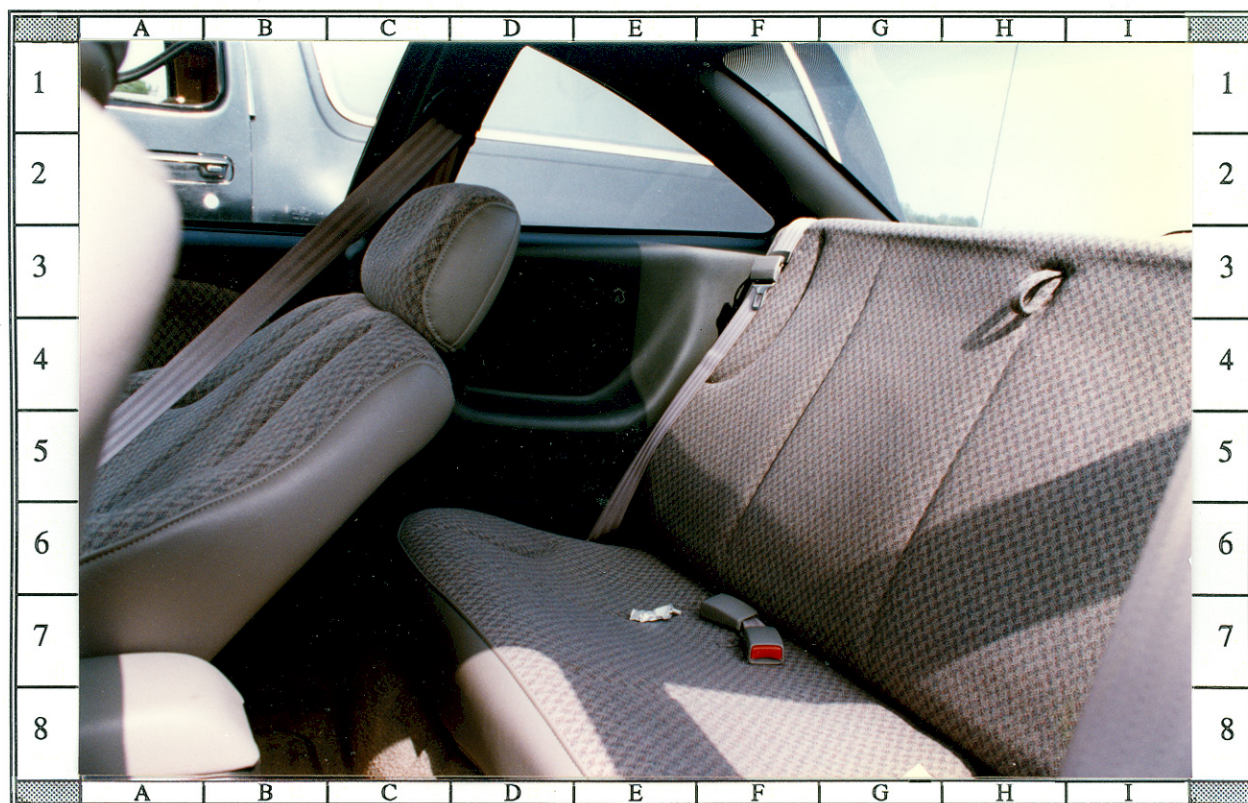
50: Case Vehicle's rear seating area; NOTE: front right seatback reclined and outboard three-point belts and no rear head restraints
